# LOCAL AUTHORITY ROADS CONFERENCE and EXHIBITION - 2022

## Regional Road Network Safety Analysis (RR NSA)

Angela McCormack & Máire Dolan
Executive Engineer & Executive Technician
Department of Transport Support Office (DoTSO)

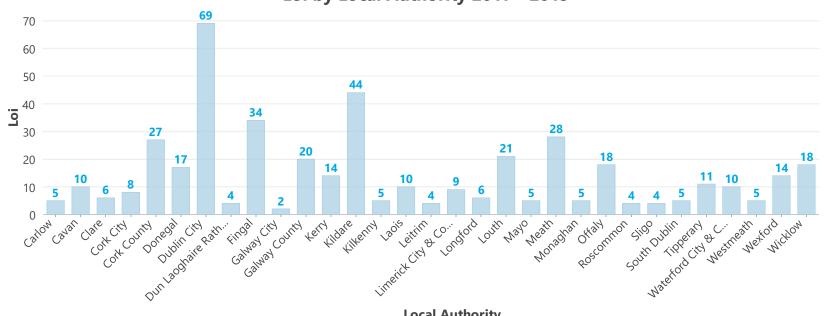
### Loi by Local Authority 2017 - 2019\*

\*RSA data - 2018 & 2019 provisional

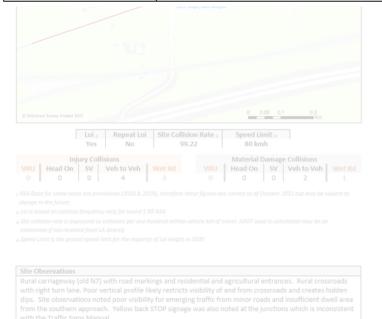
Site Ref No	Site Location	Analysis period
R445-KE-25.0	Kildare to Monasterevin road @ Cherryville	2017-2019 <sub>1</sub>

Collision Analysis

3 minor injury and 3 material damage collisions. Most collisions occurred involving vehicles travelling southbound through the crossroads and vehicles both directions on the mainline. Angle both straight was the predominant collision type. Wet surface noted in 4 collisions and dark/poor lighting noted in 3.

General Comments

Assess surface/skid resistance and junction layout, in particular sight visibility to and from the junction and advance warning signage for junction, particularly on the R44S. Assess requirement for lighting at junction. Review inappropriate signage. Assess dwell area on southern approach.

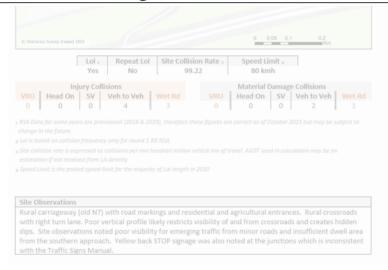
#### Site Observations

Rural carriageway (old N7) with road markings and residential and agricultural entrances. Rural crossroads with right turn lane. Poor vertical profile likely restricts visibility of and from crossroads and creates hidden dips. Site observations noted poor visibility for emerging traffic from minor roads and insufficient dwell area from the southern approach. Yellow back STOP signage was also noted at the junctions which is inconsistent with the Traffic Signs Manual.

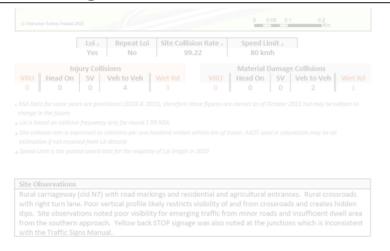
### **Collision Analysis**

3 minor injury and 3 material damage collisions. Most collisions occurred involving vehicles travelling southbound through the crossroads and vehicles both directions on the mainline. Angle both straight was the predominant collision type. Wet surface noted in 4 collisions and dark/poor lighting noted in 3.

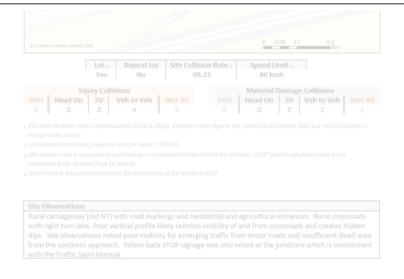
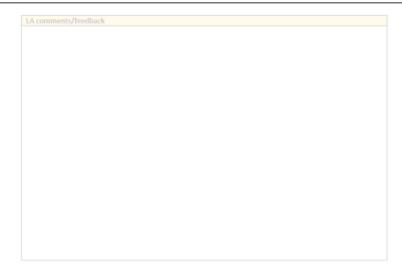
#### Collision Trends and Observations

Most collisions involved traffic emerging from the minor roads in particular travelling southbound from Rathangan. Wet surface and road factors noted 3 collisions and snow noted in another. Dark, poor lighting also noted for 3 collisions. Vertical profile of the regional road is likely to have been a contributory factor. Most collisions occurred during the weekend.

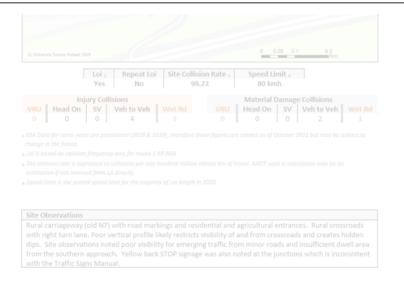
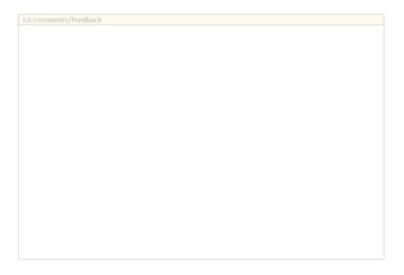
### **General Comments**

Assess surface/skid resistance and junction layout, in particular sight visibility to and from the junction and advance warning signage for junction, particularly on the R445. Assess requirement for lighting at junction. Review inappropriate signage. Assess dwell area on southern approach.
