## ROADS Services Training Group LOCAL AUTHORITY ROADS CONFERENCE and

Lyrath Estate Hotel, Kilkenny, May 2019.

## Assessing the Condition of the Irish Regional Roads Network – 2018

Dr. Kieran Feighan – PMS Pavement Management Services Ltd

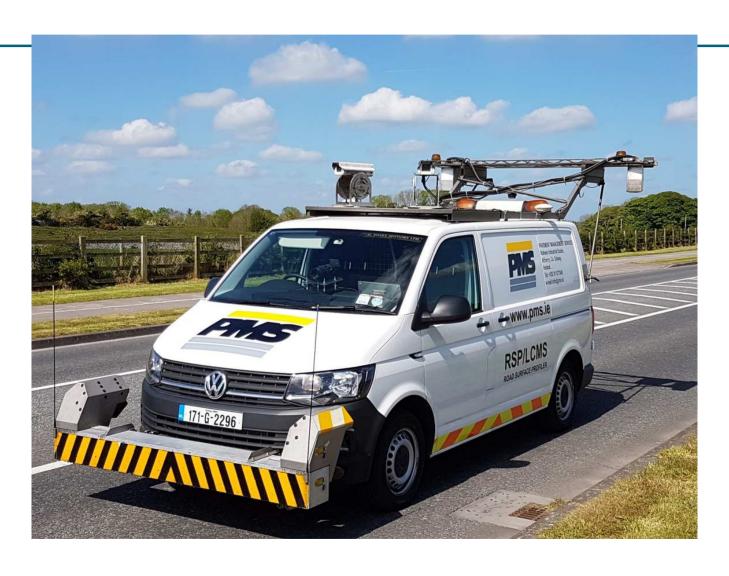
**Dynatest Mark III RSP**

- Road Condition Data (IRI, Rut & MPD)
  - Road Surface Profiler (RSP)
- Skidding Resistance Data (SC)
  - SCRIM
- Digital Video Data (Visual Rating)
  - both RSP (.JPeg) and SCRIM (.Avi)

#### **Road Surface Profiler (RSP)**

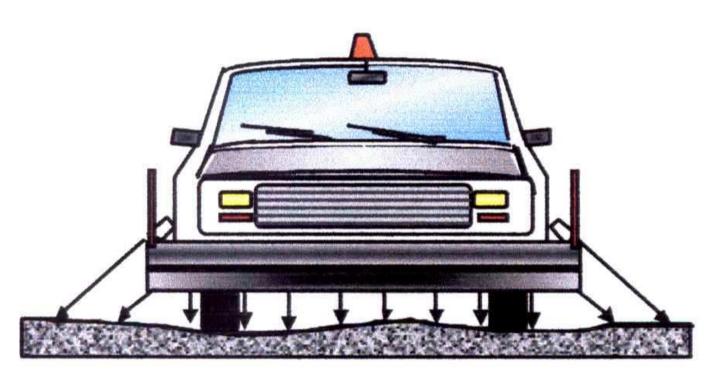
#### Cross Profile – Rut Depth

- Indication of Structural Condition
- Caused by heavy traffic and/or inadequate pavement strength
- Rutting can occur in upper layers or in underlying subgrade
- Measured in both wheelpaths in mm

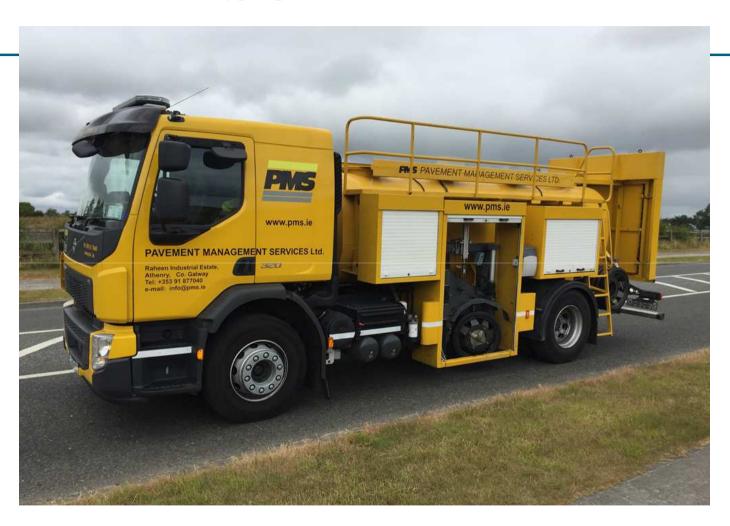
#### **SCRIM**

- Frictional properties of the road surface
  - Measured using a standard device
  - Under standardised conditions
- Measurements used to
  - Characterise the road surface
  - Assess the need for maintenance
- Low Speed (< 50 km/h): Microtexture</p>
- High Speed (> 60 km/h): Macrotexture

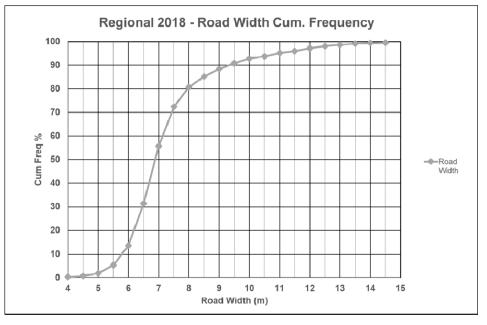
#### National Average: 7.5 m
